DRAFT Response Action Plan and Construction Contingency Plan Update

Shady Oak Properties
4312 Shady Oak Road
Minnetonka, Minnesota 55343

WENCK Associates, Inc.
1800 Pioneer Creek Center
Maple Plain, MN 55359
Phone: 763-479-4200
Fax: 763-479-4242

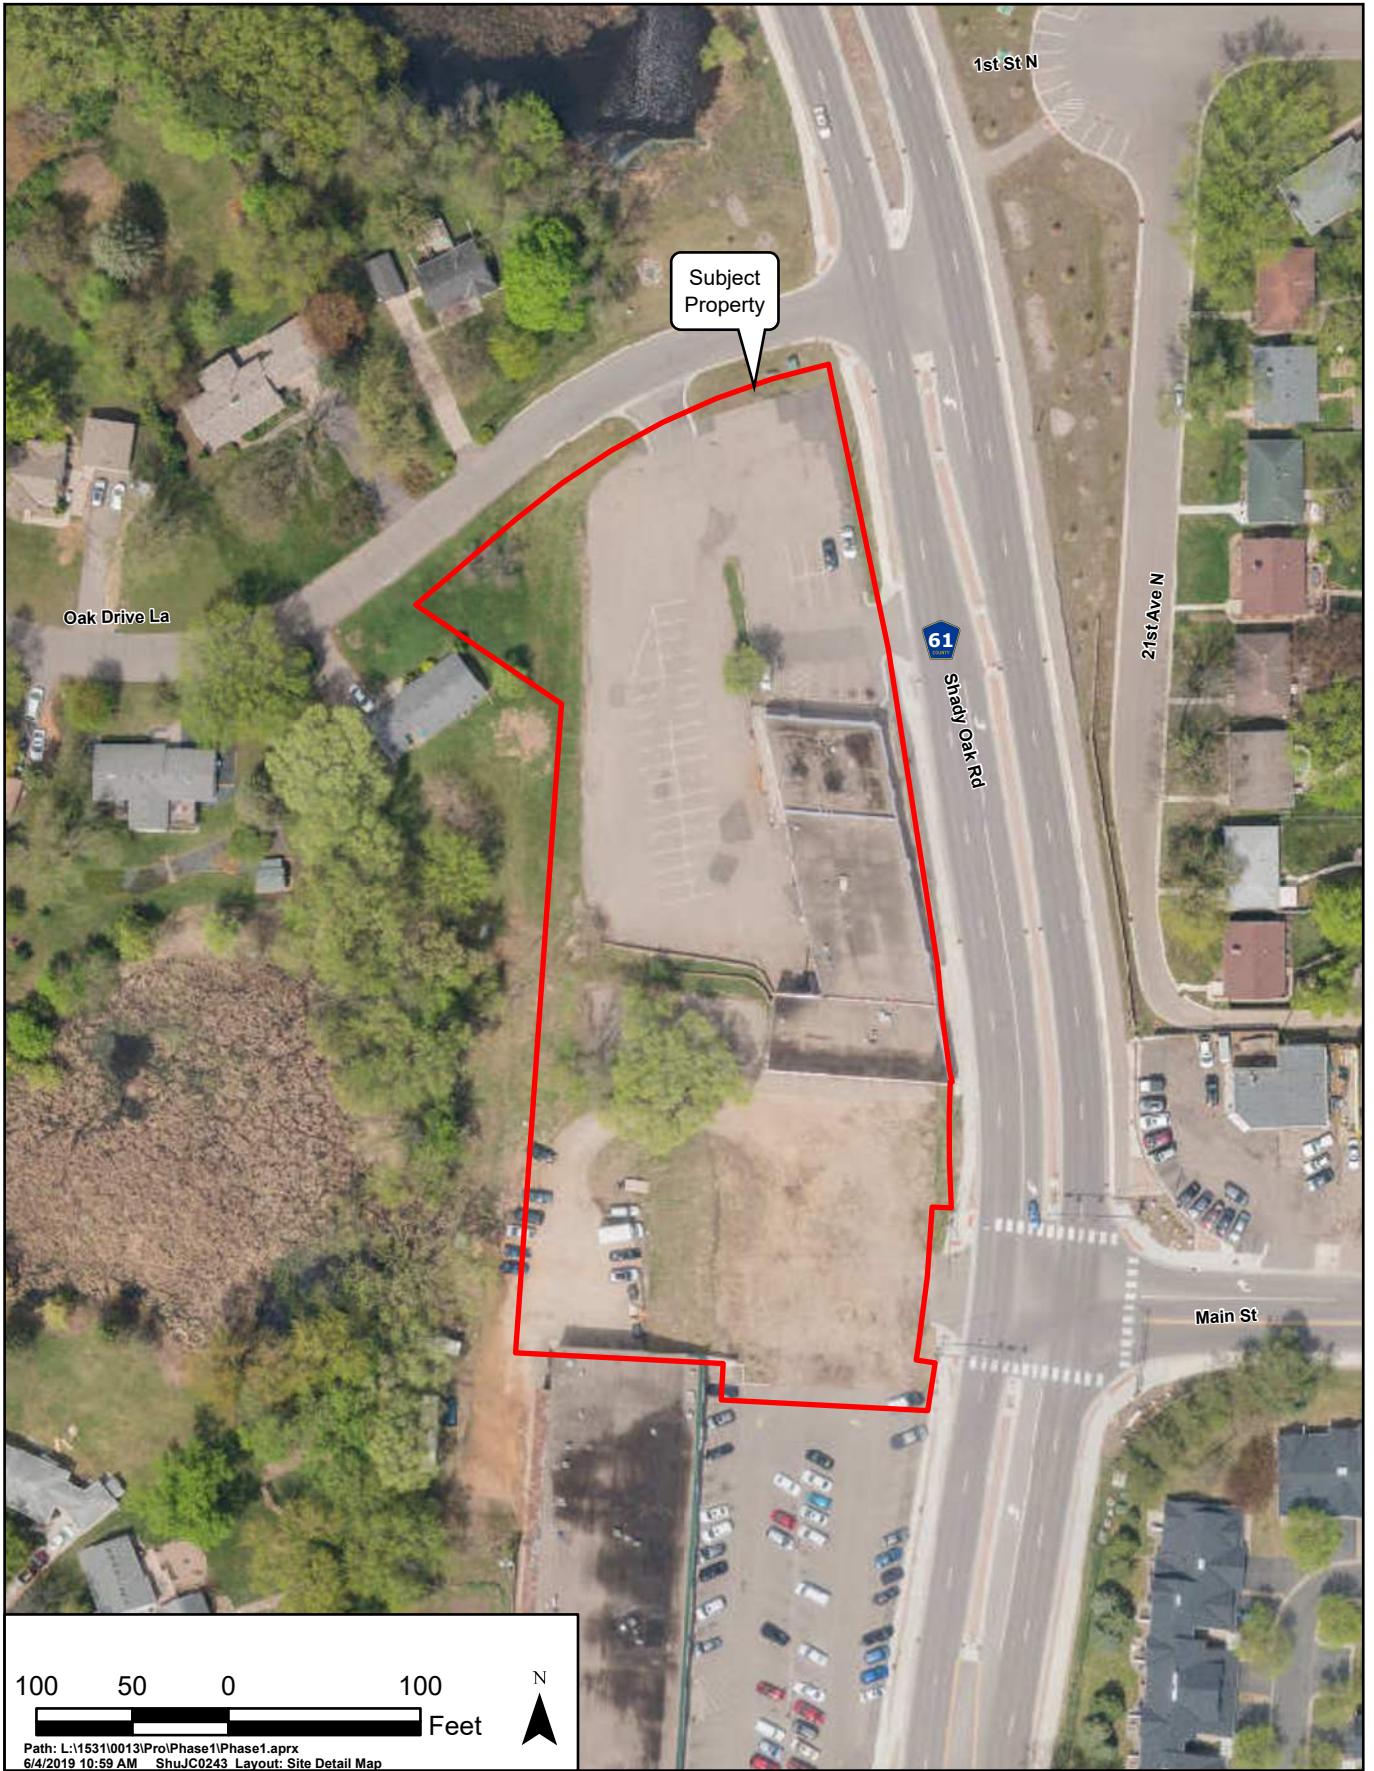
JUN 2019
Figure 2

RON CLARK CONSTRUCTION
Site Detail Map

The Subject Property consists of 2.32 acres occupied by an approximately 25,680-square-foot multi-tenant commercial/retail building with a paved parking lot, drive areas, and greenspace. Access to the Subject Property is from Shady Oak Road and Oak Drive Lane. The Subject Property location is depicted in **Figure 1**. A Site Detail Map of the Subject Property is included as **Figure 2**.

Proposed redevelopment plans at the Subject Property include the demolition of the existing structure located on the 4312 Parcel, which is shown on **Figure 2**. An Asbestos and Regulated Materials Survey, completed by Wenck in October of 2014, identified the presence of asbestos containing materials (ACM), possible PCBs and Metal Containing Items, and other miscellaneous regulated materials in the 4312 building. All regulated materials will be abated and properly disposed of in accordance with Federal and State requirements by a licensed abatement contractor. The details of the materials and the procedures to be followed are contained in a separate document.

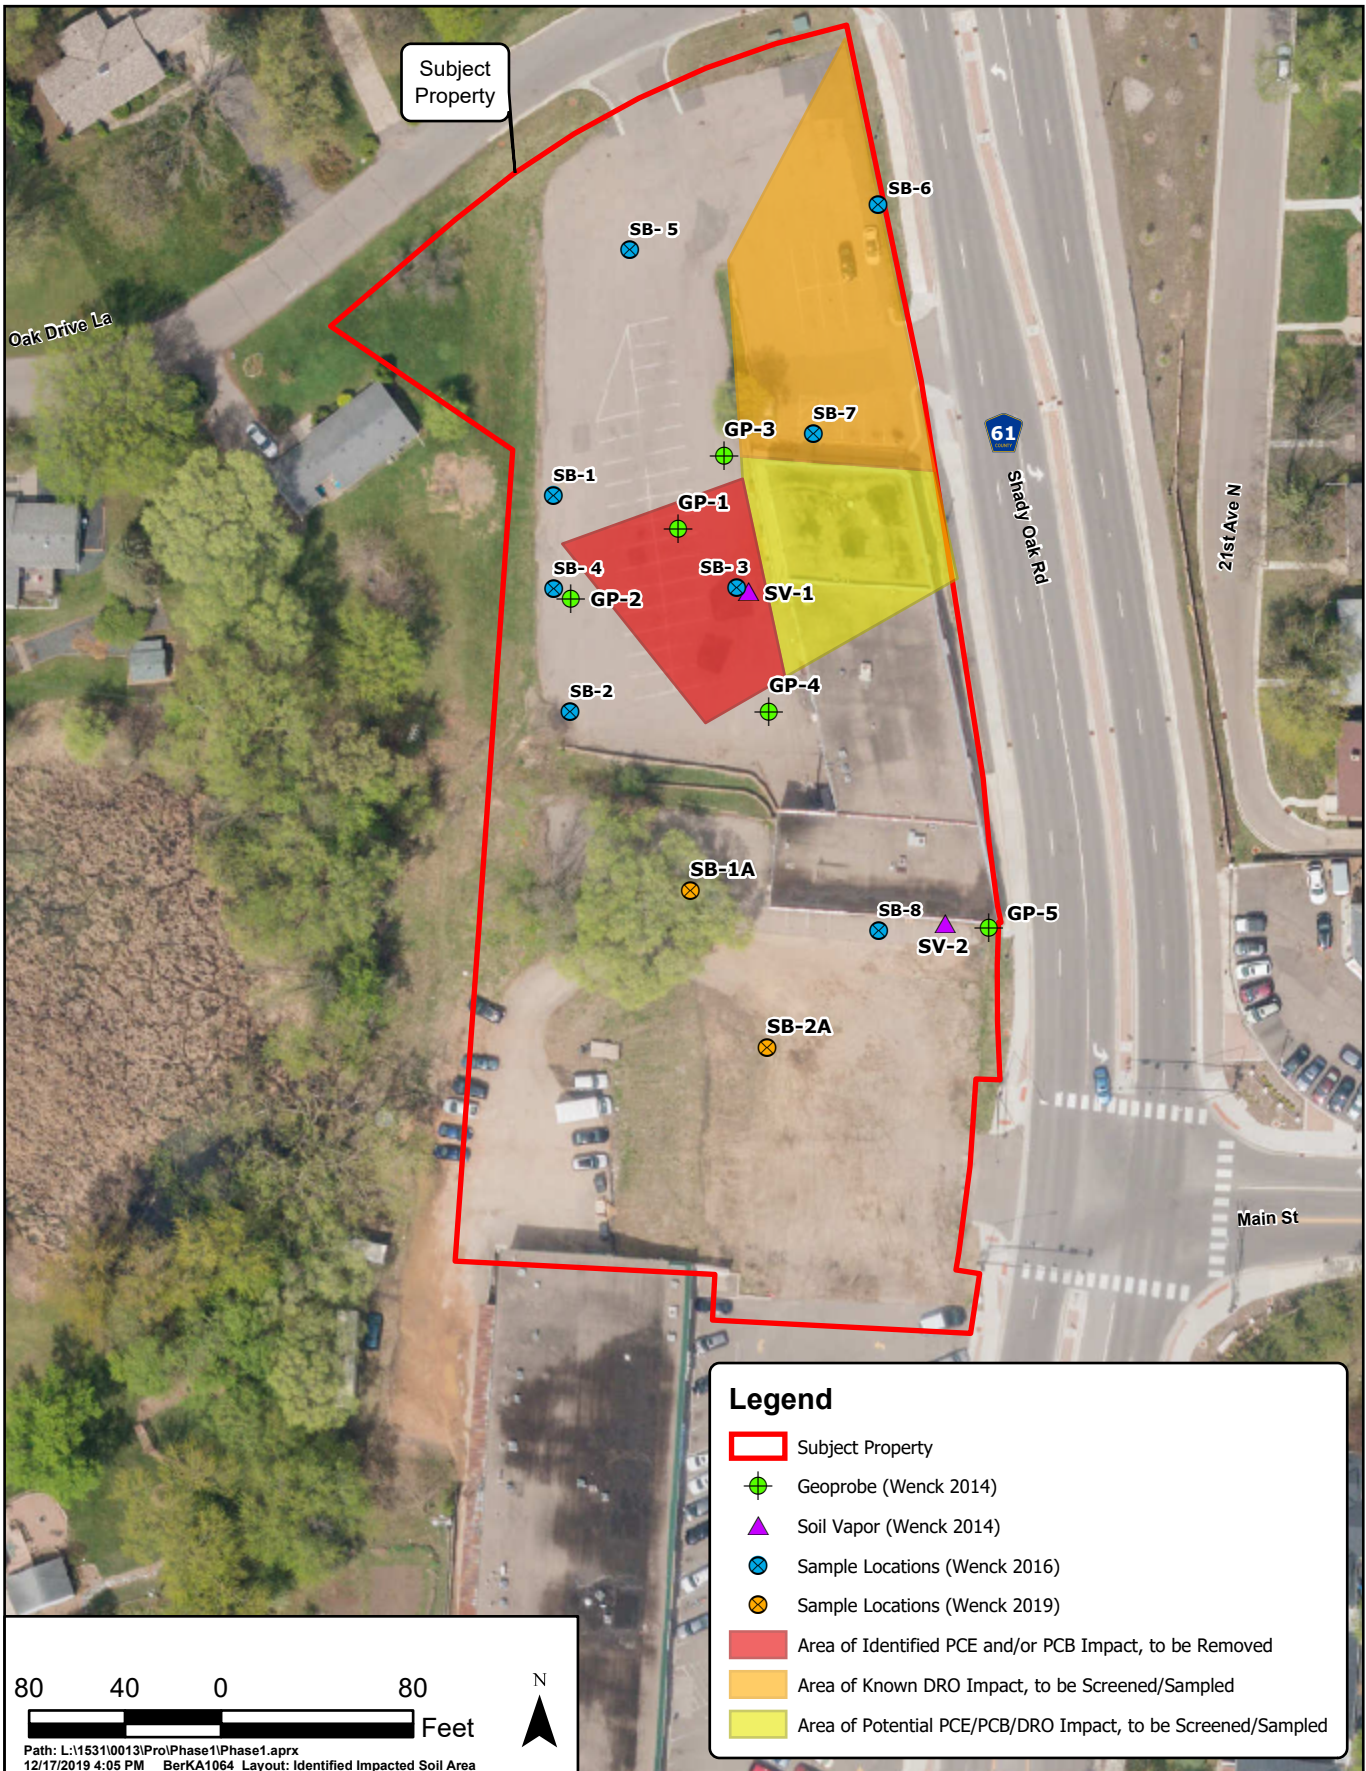
- Subject Property
- Geoprobe (Wenck 2014)
- ▲ Soil Vapor (Wenck 2014)
- ⊗ Sample Locations (Wenck 2016)
- ⊗ Sample Locations (Wenck 2019)
- Area of Identified PCE and/or PCB Impact, to be Removed
- Area of Known DRO Impact, to be Screened/Sampled
- Area of Potential PCE/PCB/DRO Impact, to be Screened/Sampled
